# RA6830JD Microprocessor Noise Fix

Dallas Lankford, 11/13/03, rev. 1/7/05

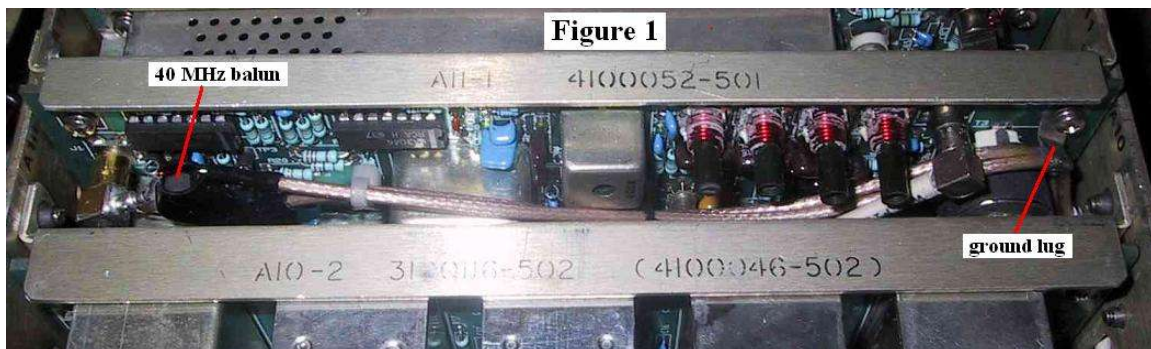
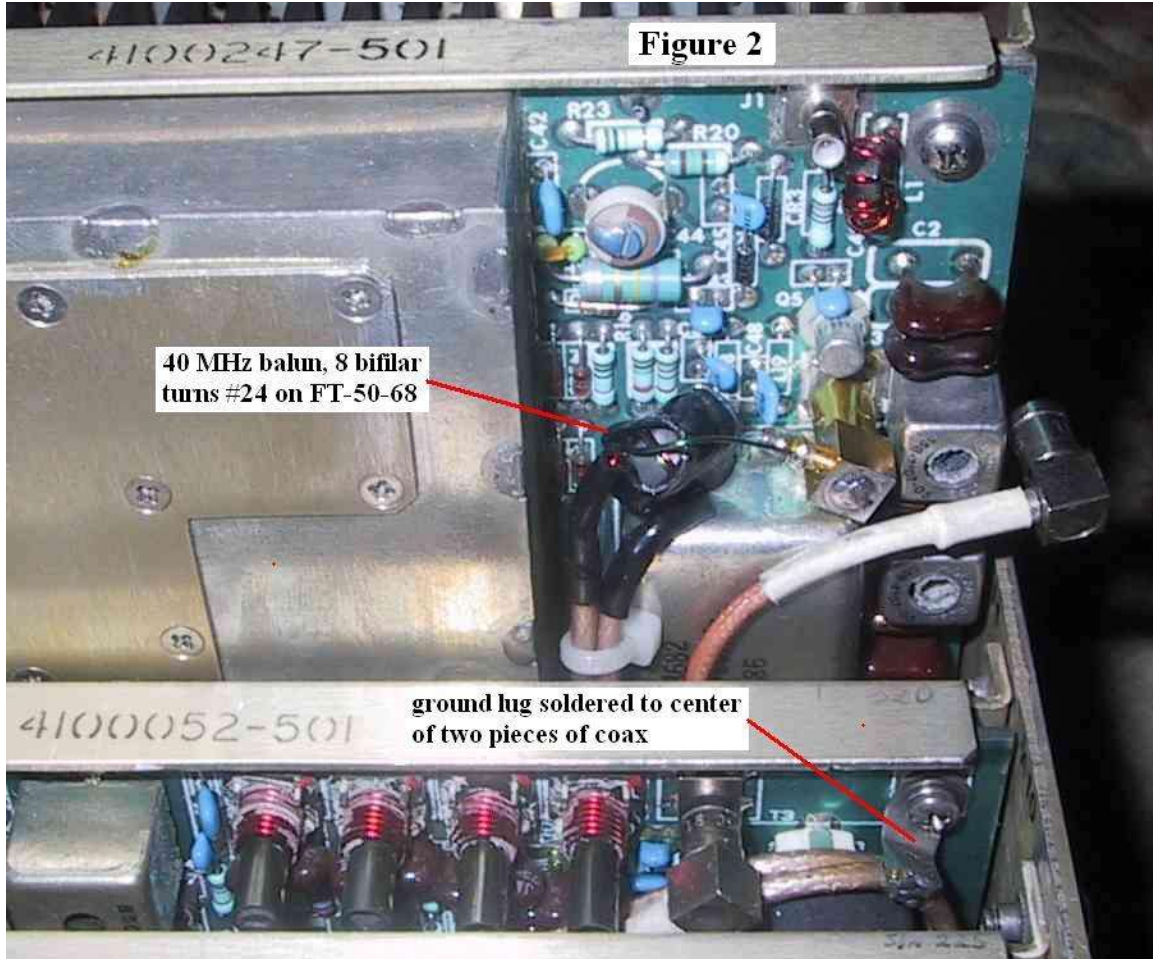
Recently, due to success at eliminating microprocessor noise from my RA6778C's, I had another go at the JD. To my surprise, I discovered that the noise was being picked up only by the 1st IF at 40.455 MHz on the 2nd mixer board. Further examination showed that the short mini coax with SMB connectors which connects the 1st mixer board to the 2nd mixer board was acting as an antenna.

About 99 % of the microprocessor noise in my RA6830JD is now gone. A few isolated spots of noise remain, but most of these are also heard on my RA6830-516's, although more weakly. These remaining isolated spots of microprocessor noise vary in strength with respect to time. On some occasions few, if any, are heard. At this time I do not know the reason for the noise strength variation.

I fabricated two small 40 MHz baluns using 8 bifilar turns of #24 on Amidon FT-50-68 toroids, soldered the unbalanced leads directly to SMB (m) connectors, and the balanced leads to the center conductors of pieces of RG-316 approximately the same length as the original mini coax. At the center points of the two pieces of RG-316 I soldered their braids together with a short length of #22 solid, and in turn soldered that to a ground lug that I added to one of the mounting screws. I routed the dual RG-316 through the side plates, as the original had been routed. Actually, the routing took place before the second balun was soldered to RG-316. Figures 1 and 2 below show these changes to the 6830.
