## **NRD-92M Noise Problems**

**Dallas Lankford**

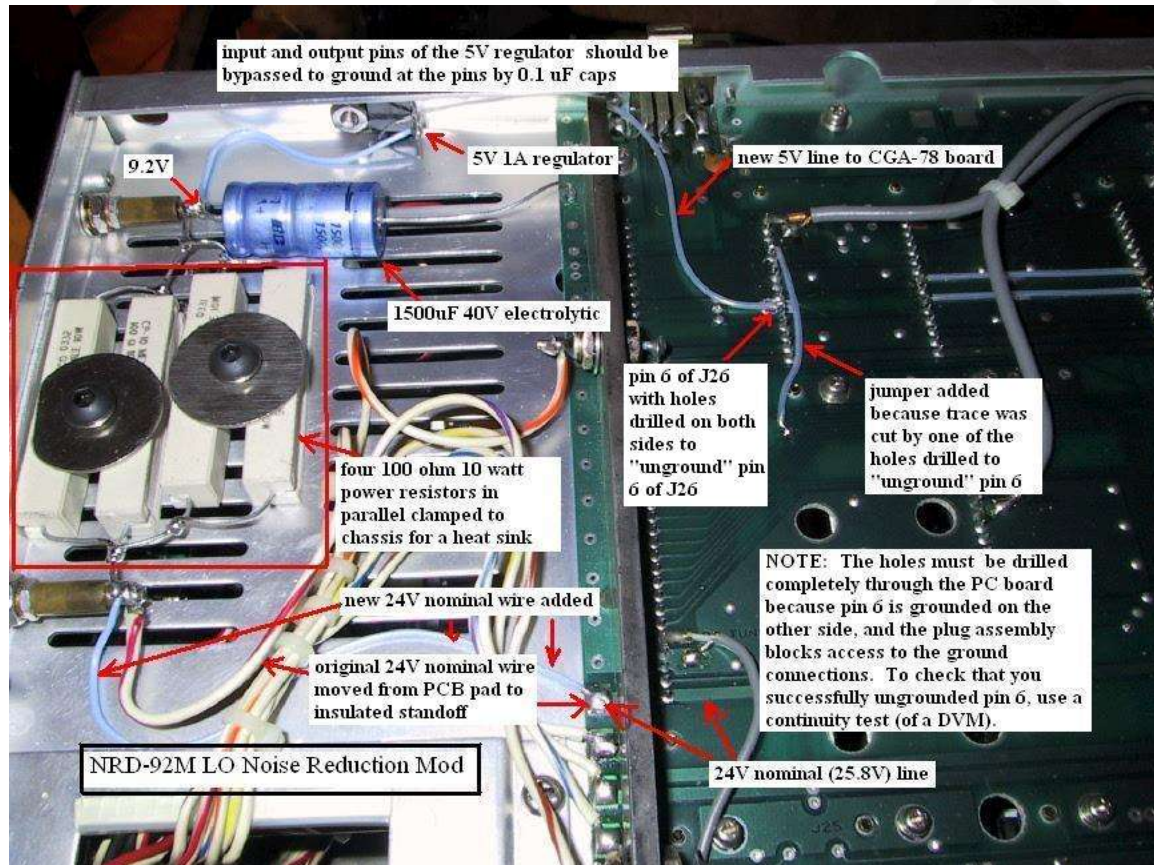
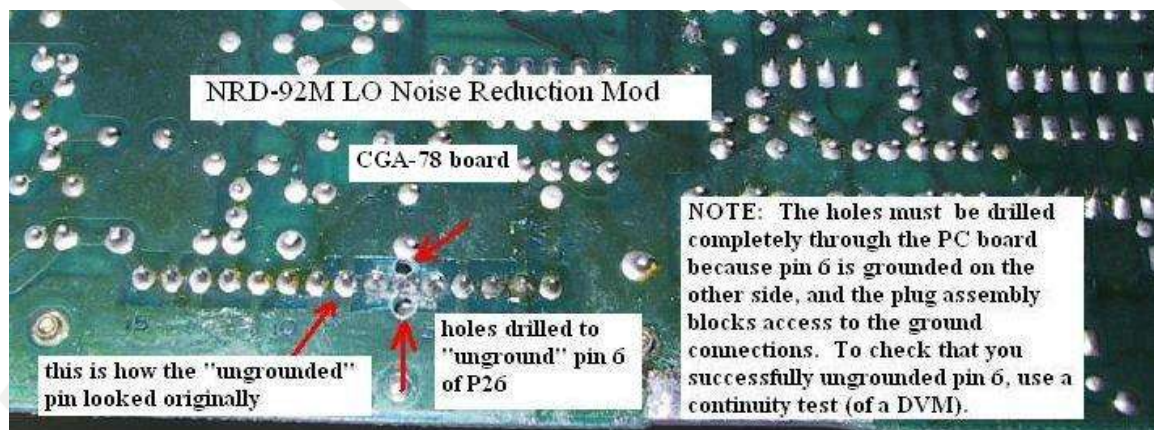
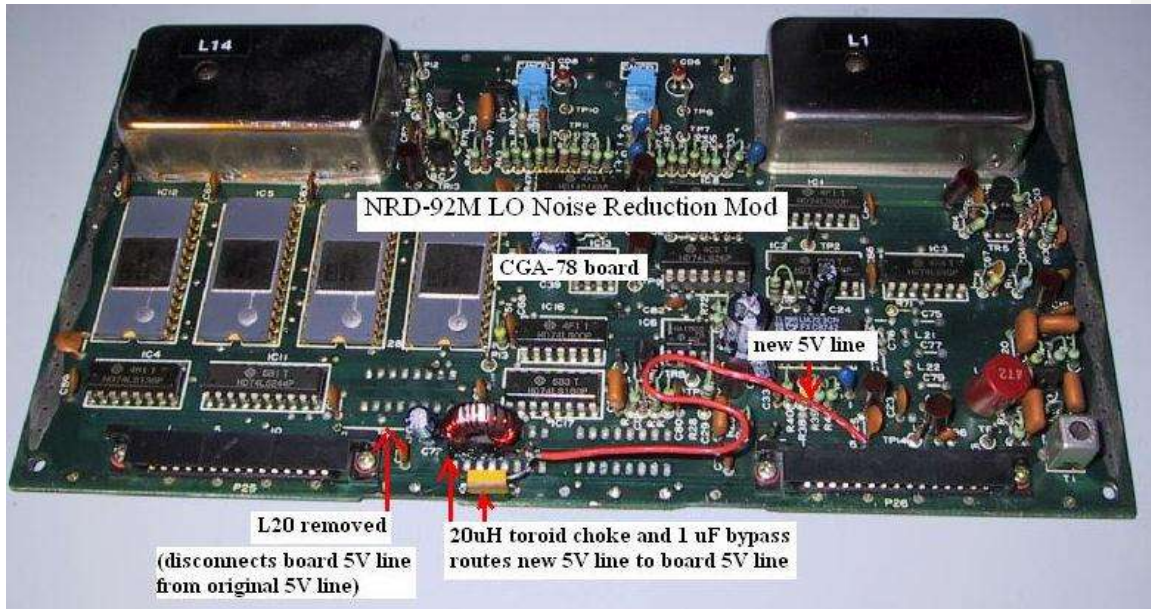
Eventually I decided that dropping resistors was not the best solution for the additional 5 volt power supply. So I removed them and used 10, 15, and 20 volt 3 pin regulators bolted to the chassis sides to drop the voltage from 24 volts to 10 volts for the 5 volt 3 pin regulator.

The voltage regulator must also be heat sinked. At first I used a finned heat sink, but the 7805 ran at 62° C, closer to the 70° C maximum rating than I wanted. So I bolted it to the chassis rear, which also forms part of the rear panel. Now the 7805 runs about 45° C, less than the 92M power supply, which is about 52° C as measured on the heat sink fins through the side panel with the room at 23° C ambient. At turn on, the input voltage is about 7.8V, just slightly higher than is needed to meet the dropout voltage condition. After about 30 minutes warm up, the 5V regulator input voltage is about 9.2V. More details of the mod are given in the pictures below. BTW, now I can hear the close-in LO spurs (which is normal) that I couldn't hear before because they were below the noise.
